# Smoke and Dye Testing Summary

## High Level Sewershed

Test ID	Test Type	Date Inspected	Company / Super.	Blower MH	Ground Condition	Notification Made?	Total Length
S1028-215	Smoke	8/10/2009	ADS/TM	S19KK_053MH	Dry	Yes	563.38

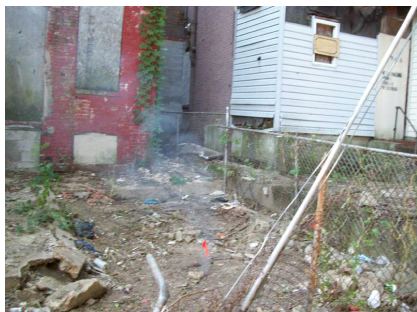
**Picture** \S1028-215-OB01-P01.jpg

**Comments** Smoke from cleanout in back yard. 1904 Walbrook Ave.

**Comments** Back of house, 1904 Walbrook Ave.

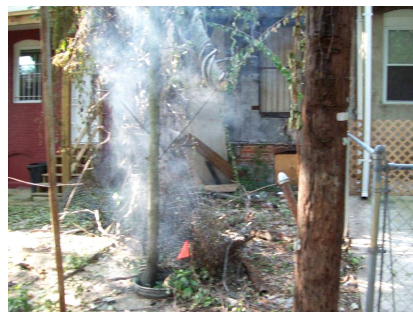
**Picture** \S1028-215-OB02-P01.jpg

**Comments** Smoke from cleanout in back yard. 1924 Walbrook Ave.

**Comments** Back of house, 1924 Walbrook Ave.

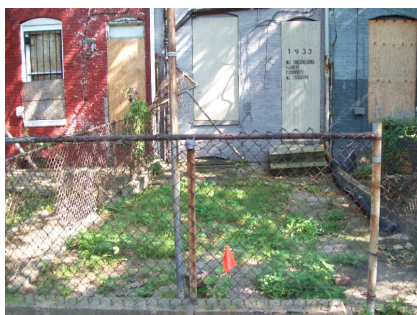
**Picture** \S1028-215-OB03-P01.jpg

**Comments** Smoke from above-grade cleanout in back yard. 1933 Ridgehill Ave.

**Comments** Back of house, 1933 Ridgehill Ave.

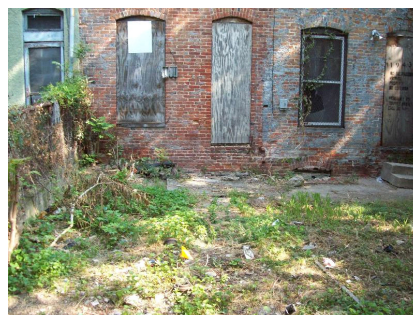
**Picture** \S1028-215-OB04-P01.jpg

**Comments** Smoke from cleanout in back yard. 1945 Ridgehill Ave.

**Comments** Back of house, 1945 Ridgehill Ave.

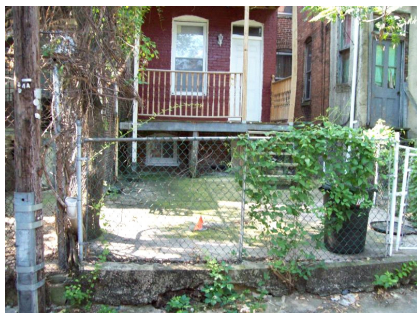
**Picture** \S1028-215-OB05-P01.jpg

**Comments** Smoke from cleanout in back yard. 1942 Ridgehill Ave.

**Comments** Back of house, 1942 Ridgehill Ave.
